The Human Factors Relating to Escape and Survival from Helicopters Ditching in Water

THE HUMAN FACTORS RELATING TO ESCAPE
AND SURVIVAL FROM HELICOPTERS DITCHING IN WATER

This AGARDograph was sponsored by the AGARD Aerospace Medical Panel.

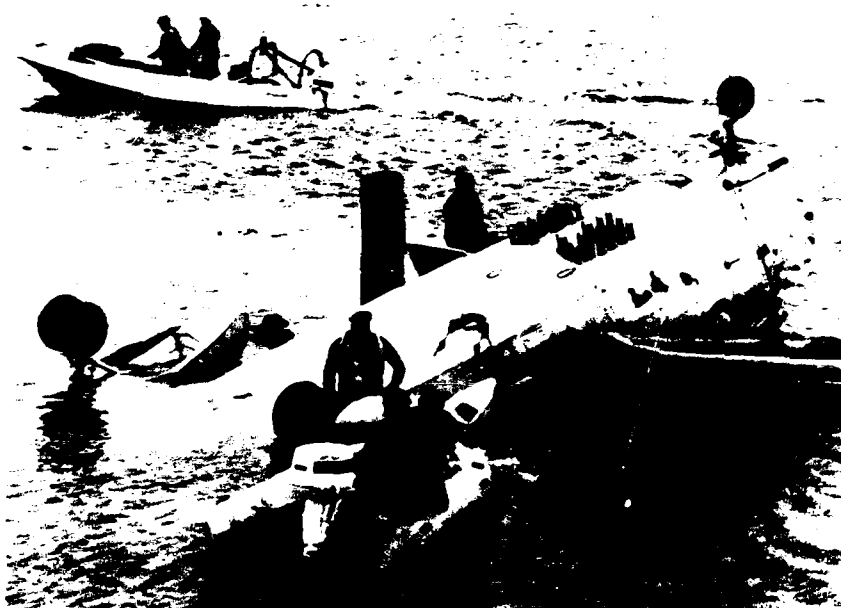
Figure 2. Typical helicopter accident where the helicopter sinks and is rapidly inverted.

The introduction of the helicopter has produced unique problems related to survival after impacts particularly underwater escape for aircrew and passengers. Although helicopters tend to be lighter and more buoyant than fixed-winged aircraft, after ditching they either float upright (Figure 1), float inverted (Figure 2) or sink inverted. Unfortunately, unless there is a very calm sea state, the latter two situations occur more frequently and are more likely to result in loss of life. For instance, the Sikorski S61 is designed to stay afloat (if intact) up to conditions of Sea State 3; yet in the North Sea, where it is very commonly used, the sea state exceeds 3 for much of the year.

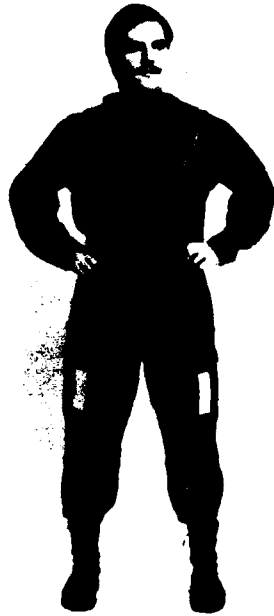
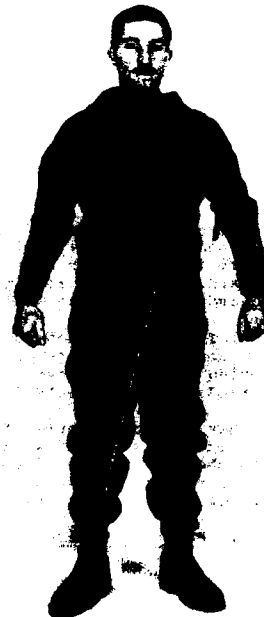
Figure 16. Principle types of helicopter survival suits used in military and civilian operations.

A. CF double layered cotton ventilate suit,
- Horseshoe zip.
(Courtesy Mustang Industries Inc.)

B. CF Quick-don suit, - Semi-vertical zip.

D. USN Gortex Nomex suit. - Transverse zip.
(Courtesy N.A.D.C. Warminster, Pa.)

Allan (7) in 1983 established very good guidelines for policy makers on how much insulation is required in an immersion suit at different water temperatures. Because water conducts heat 27 times more rapidly than air and the sea water temperature in areas where NATO operates barely reaches the upper teens Centigrade even in summer, a dry suit must be worn (Figure 16).

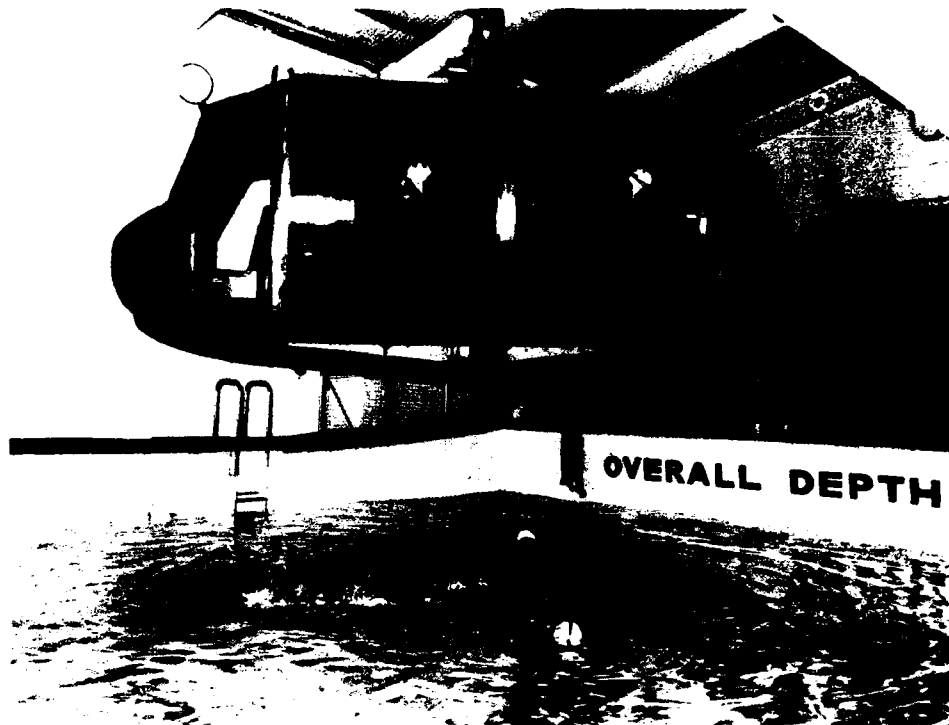
Figure 20. Typical types of helicopter underwater escape trainers.

A. Robert Gordon's Institute of Technology, Aberdeen, Scotland HUET.

The following helicopter underwater escape trainers are currently in service in the Western World (Figure 20).
